## TECHNICAL SERVICE BULLETIN

**Product: QUEST ELITE**

**Subject: Harness Seal Issue – Quest R290 Dispenser**

**File: TSB-25-BQE-03**

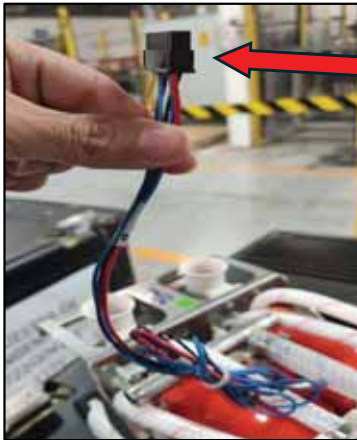
← Remove this black connector. this connector is present in harnesses **PN-620073390** and **PN-620072337**. If the unit is a 2-flavor model, you'll only find one connector. If it's a 4-flavor model, you'll find two, one on each side of the platform.

13. You are going to start removing all cables of harness 620073390 Rev B or 620072337 Rev A. But first, follow the next steps:
